**RE: Notice of Violation:  
American Sand Sites  
Monterey Highway, Putnam County  
NPDES Permit # TN0079901, TN0066249, TN0062910**

**American Sand Supply  
Photo Documentation**  
Photos taken by WPC personnel Rita  
Thompson on December 28, 2009

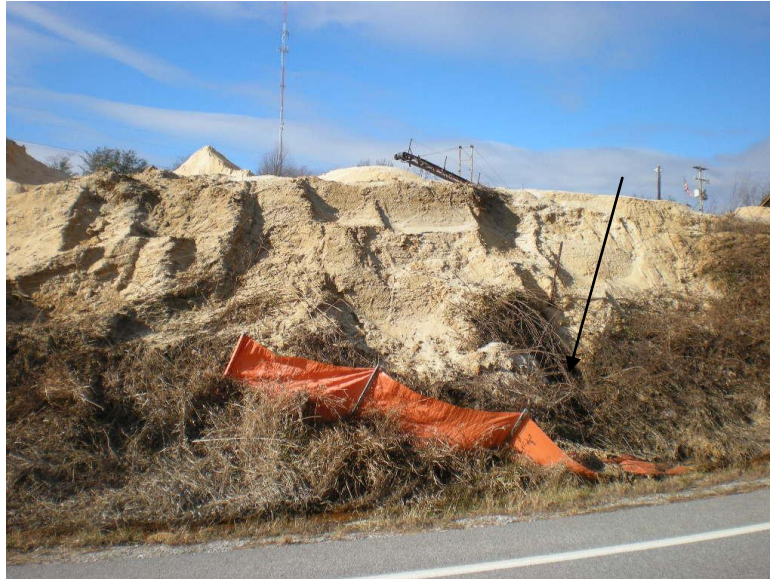
- Sediment loss was noted from the processing plant (TN0062910) into the ditchline at Hwy 70. In addition, silt fencing preventing sediment loss from the slopes was down and in need of maintenance.

**Photo 1 (TN0062910) – Silt fencing down in the vicinity of the processing plant. Sediment loss noted in ditchline adjacent to Hwy 70.**

- ✓ Please submit a response in writing to this office by January 8, 2010. This response should include an explanation of the activities and descriptions of the methods used to remedy the above-mentioned violations.

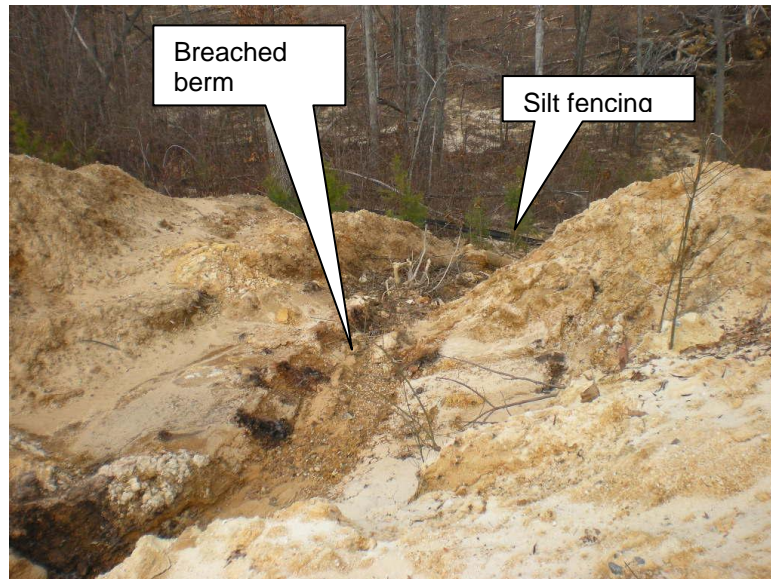
- At the 40 acre site (TN0066249), the berm at sediment basin 002 appears to have breached and sediment loss is occurring from the mining site. Silt fencing in that area is down and allowing continued sediment loss. In addition, a window was noted in the berm at the rear of the property allowing sediment to escape the site. The rock filter berm called for in the SWPPP was not noted onsite. Clearing activities were taking place onsite.

**Photo 2 (TN0066249) - Berm breached at 40 acre site allowing sediment loss in the vicinity of sediment basin 002.**

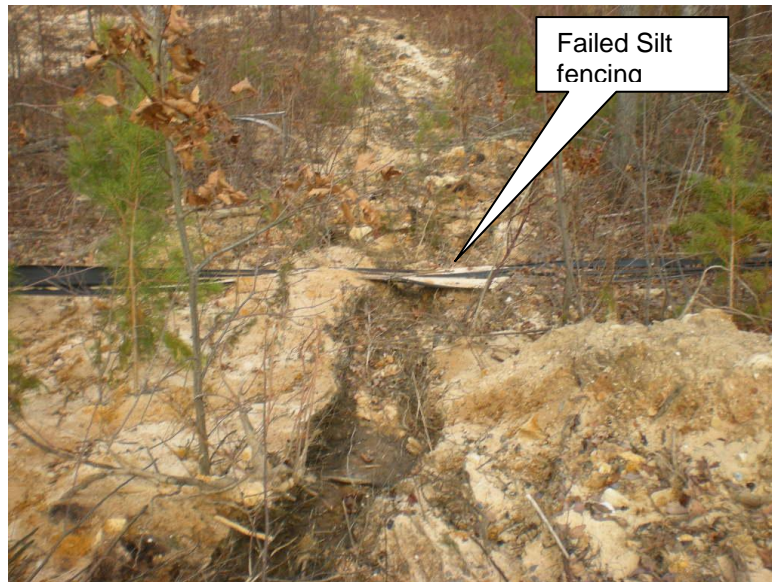
**Photo 3 (TN0066249) – Silt fencing requires maintenance downslope of berm breach. Note sediment loss beyond silt fencing.**

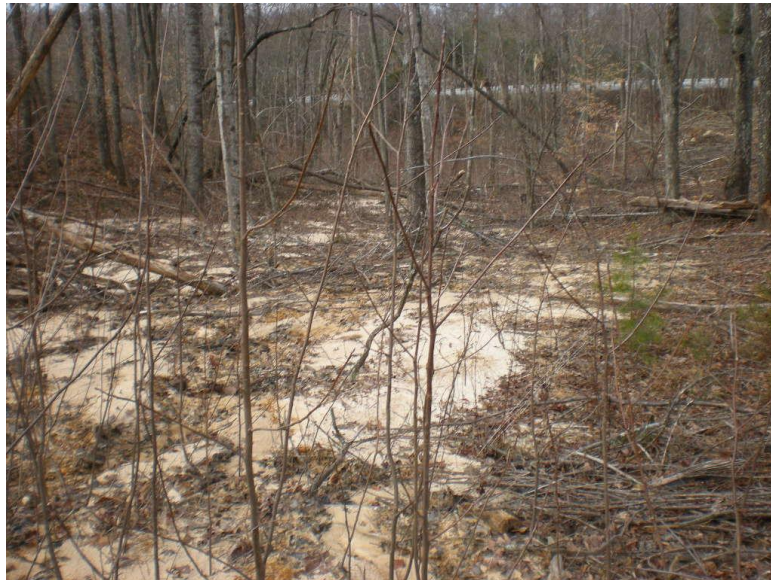
**Photo 4 (TN0066249) – Sand loss continues down grade of the mining area.**

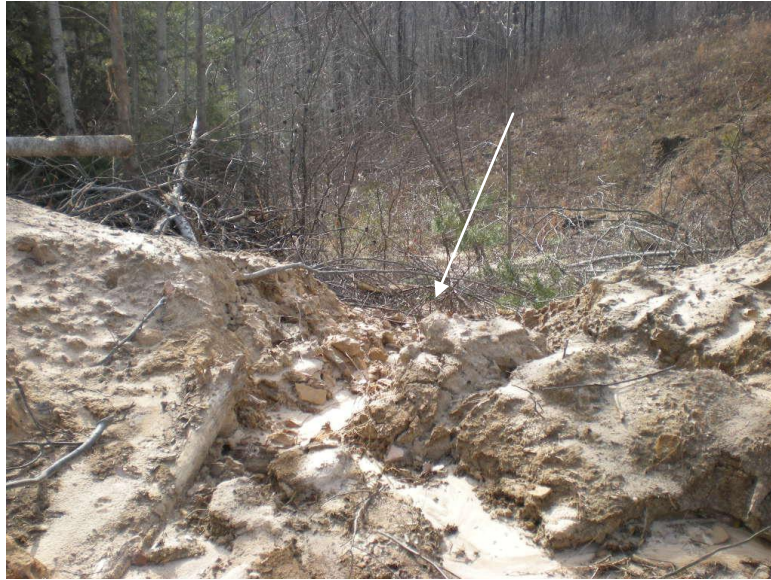
**Photo 5 (TN006249) – At the 40 acre site, a berm at the rear of the property has been breached and sediment loss is occurring offsite of the mining area.**

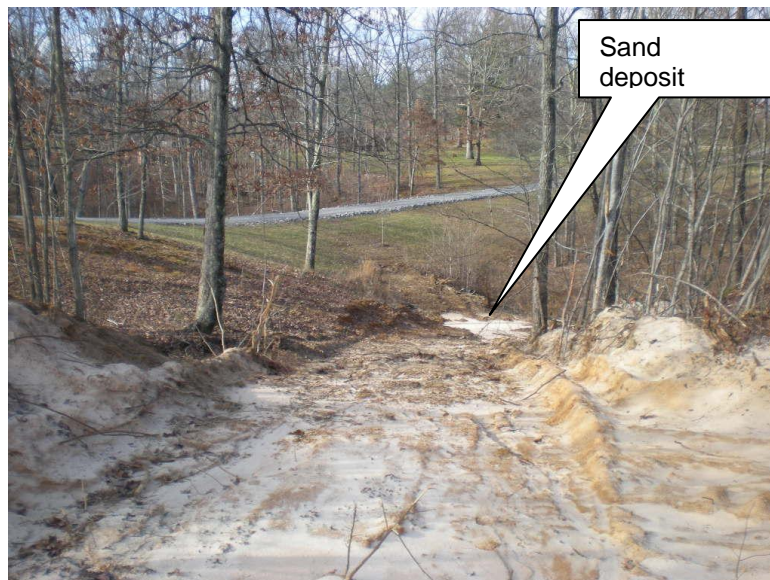
- A berm at the west side of the Quarry No. 1 Site (TN0079901) has been breached and sediment has accumulated in the vicinity of a small tributary to the Jake Hollow. The window in the berm should be closed and the sand removed to a location where loss to state waters cannot occur.

**Photo 6 (TN0079901) – Berm at Quarry No. 1 has been breached and sediment loss occurring downgradient of mining area.**

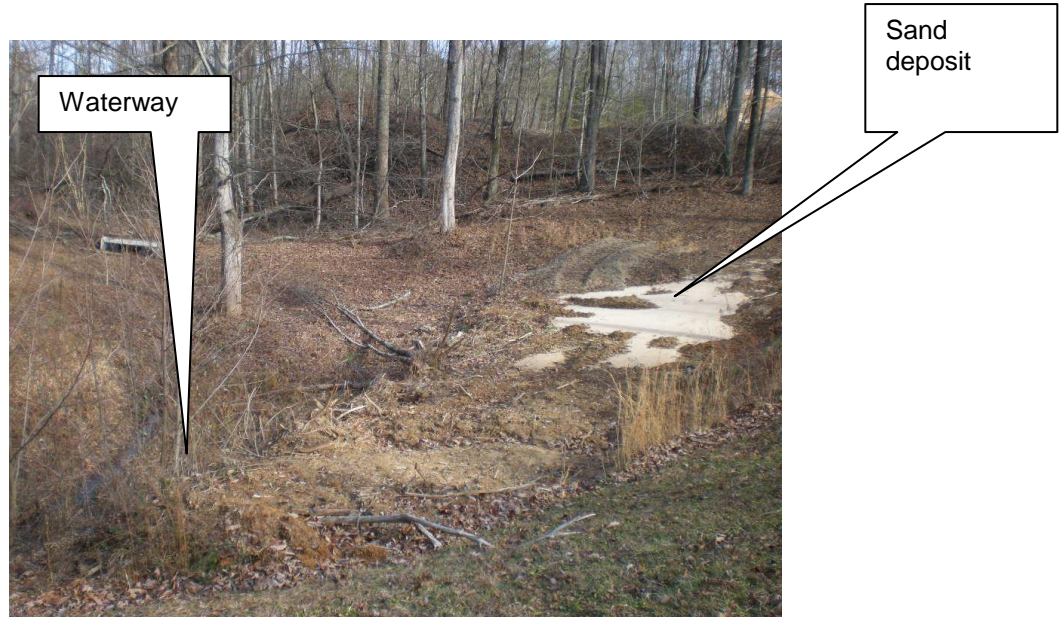
**Photo 7 (TN0079901) – Sand deposit from breached berm in the vicinity of a small tributary to the Jake Hollow.**
